Stage 1/2 Road Safety Audit

Strategic Housing Development, Dunlo, Ballinasloe, Co Galway

On behalf of Limekill Esker Ltd

August 2022

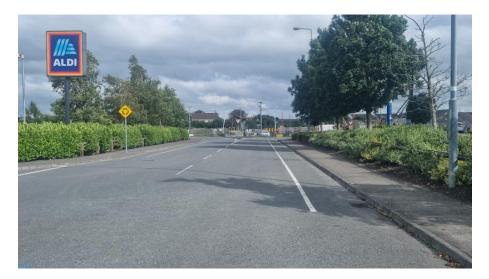
3.2.2 On-road cycle lane

Problem: There are no details of the proposed on-road cycle lane given, however the existing section of road incorporates a cycle lane at road level.

Hazard: If this existing arrangement is provided on the proposed works, the carriageway cross section becomes very wide resulting in higher than desirable vehicle speeds. Additionally, the protection to the cyclist is reduced.

Recommendation: Provide a cycle lane that is elevated above the carriageway level but remains lower than the footpath level. The width of this cycle lane should be in compliance with the National Cycle Manual.

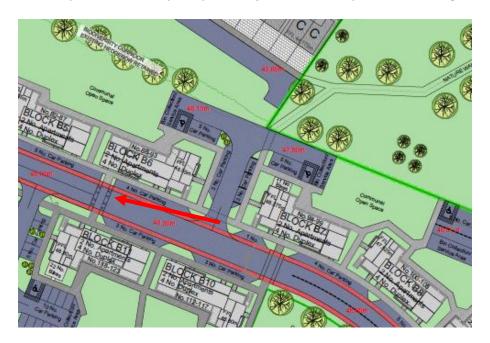
3.2.3 Junction visibility

Problem: Car parking bays are located to both sides of some of the internal junctions. High-sided vehicles parked in the bays may restrict junction visibility for users exiting the side roads.

Hazard: Side road traffic may proceed into the path of mainline traffic.

Recommendation: Ensure adequate junction visibility is achieved.

3.2.1	Yes	Yes		
3.2.2	Yes	Yes		
3.2.3	No	Yes	The main road is 10m wide, including the cycle provision. Furthermore, a buffer marking is proposed to encourage parkers to park close to the kerb and away from the cycle facility (in response to Paragraph 3.2.4 of the RSA). The detailed design will ensure motorists emerging from side roads will have a sufficient setback (x-distance) to provide an adequate Y distance in both directions.

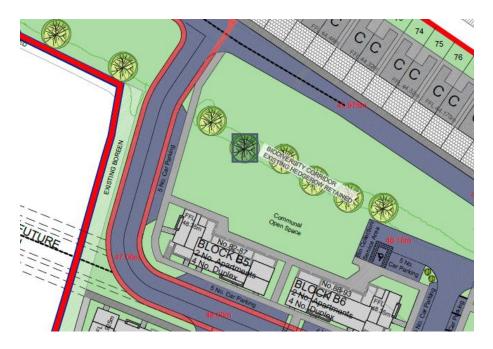
3.2.4 Car Parking Bays / Cycle Lane

Problem: The cycle lane is tight adjacent to the car parking bays. Although no width of the car parking bay is indicated on the drawing, it is likely the parked vehicle will be close to the edge of the cycle lane.

Hazard: Drivers may open their door into the path of approaching cyclists.

Recommendation: Provide a buffer strip between the cycle lane and parking bay to accommodate a partially open door.

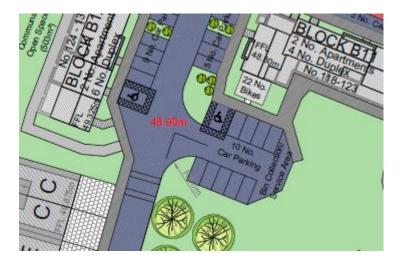
3.2.5 Disabled User Parking Bays

Problem: The disabled user parking bays extend into the "live" carriageway.

Hazard: Users of the bays who are attempting to access/egress the rear of their vehicles may be struck by passing traffic.

Recommendation: Ensure the rear of the disabled user bay does not extend further into the carriageway than the adjacent parking bay.

3.2.4	Yes	Yes	Buffer strip to be provided within parking bay	
3.2.5	Yes	No	These bays are not located on roads subject to through traffic. Where the bays are not at the end of cul-de-sacs with no parking directly opposite, they will be relocated to be such, or altered so that the the rear of the disabled user bay does not extend further into the carriageway than the adjacent parking bay.	Yes

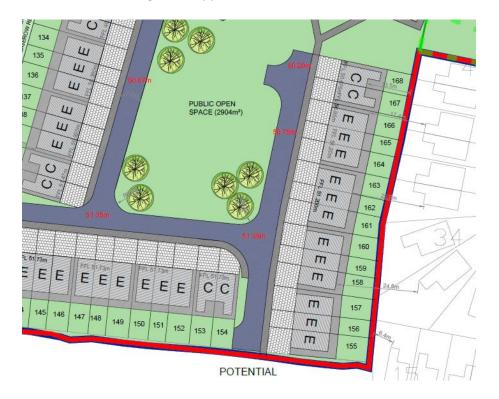
3.2.6 Turning Heads

Problem: The turning heads appear small.

Hazard: Refuse vehicles may over-run the adjacent footpath or may decide to reverse over long distances, both with the potential of impact with NMU traffic.

Recommendation: Ensure the turning heads are of adequate size.

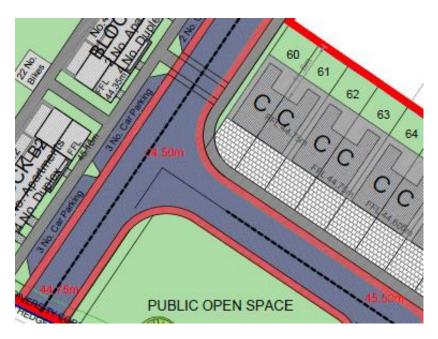
3.2.7 Cycle Lane at Junctions

Problem: The design of the cycle lane does not make allowance for cyclists to turn right out of the minor arm in safety.

Hazard: The cyclist may be struck by motorists.

Recommendation: Redesign the cycle lane and implement the recommendations shown in the national cycle manual

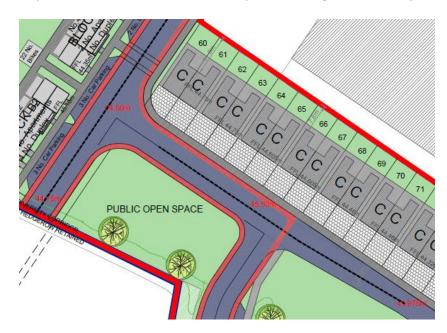
3.2.8 Cycle Lane – Road Crossing

Problem: The design drawings show the cycle lane turning 90 degrees across the road. There is no requirement for the motorist who may be travelling west-east to yield to the cyclists.

Hazard: Impact between the motorist and cyclist may result.

Recommendation: Redesign the cycle lane / road junction to indicate priority to one of the users.

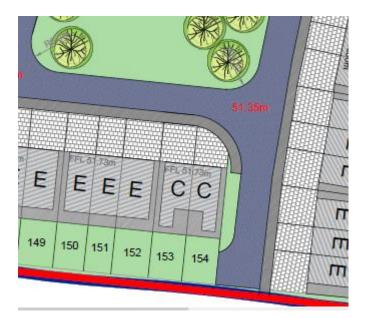
3.3.1 Car Parking – Plot 154

Problem: The driveway for plot 154 seems very small.

Hazard: There is risk that parked cars may overhang the footpath and require pedestrians to enter the carriageway to pass.

Recommendation: Ensure the driveway is of adequate size.

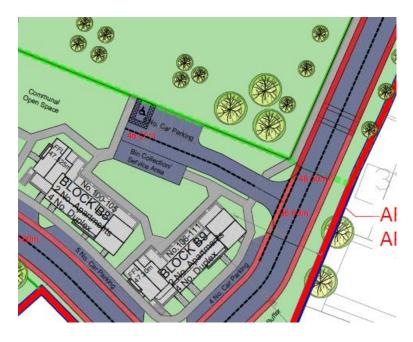
3.3.2 Bin Collection Area to Rear of Block B8

Problem: There is nowhere for the refuse collection vehicle to turn near the bin collection area.

Hazard: The refuse collection vehicle may attempt to reverse back onto the major carriageway. Impact with passing traffic may result

Recommendation: Provide a turning head of suitable size.

3.2.6	Yes	Yes	These will be revised at Design Stage	
3.2.7	Yes	Yes		
3.2.8	Yes	Yes		
3.2.9	Yes	Yes		
3.3.1	Yes	Yes		
3.3.2	Yes	No	Bin storage area to be relocated closer to junction to avoid need for refuse truck entry	Yes
